| DWG NAME | 12269F-ds3p | DATE | SEPTEMBER, 2014 |

HILLSIDE ESTATES - PHASE 4  
**WATER QUALITY POND "A" PLAN**  
 TOWNSHIP OF COPLEY, COUNTY OF SUMMIT, STATE OF OHIO

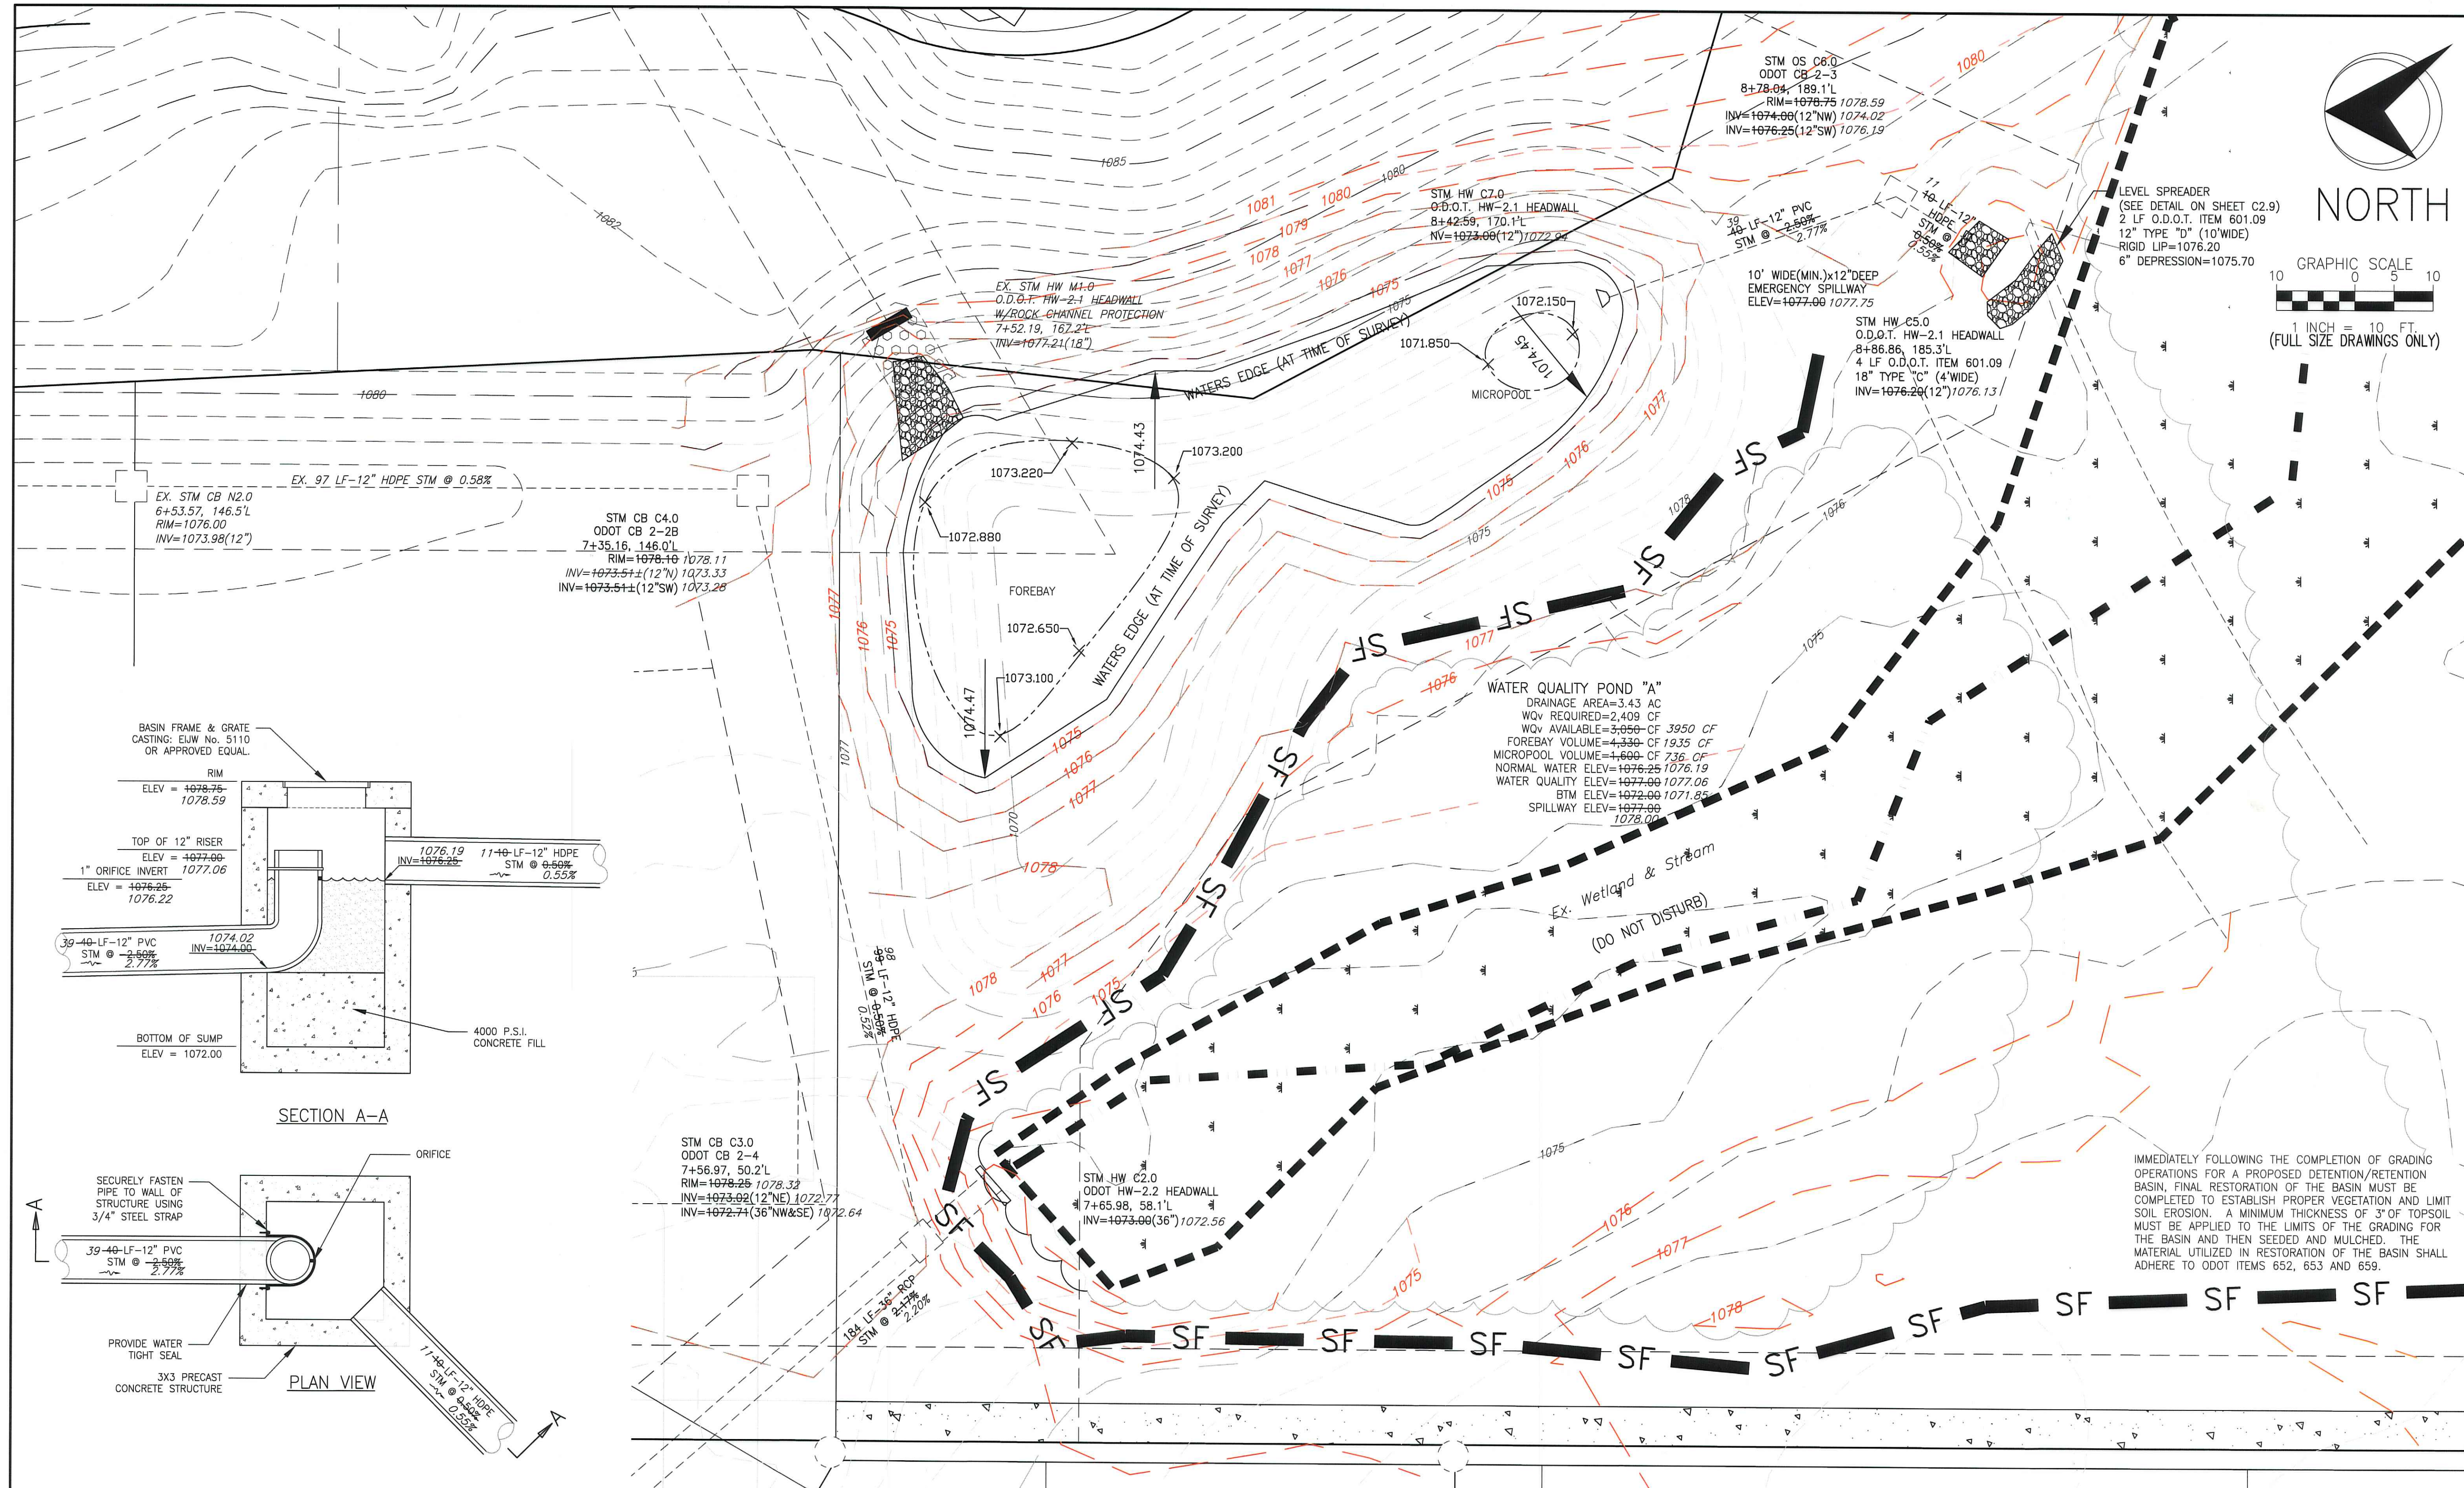
IMMEDIATELY FOLLOWING THE COMPLETION OF GRADING OPERATIONS FOR A PROPOSED DETENTION/RETENTION BASIN, FINAL RESTORATION OF THE BASIN MUST BE COMPLETED TO ESTABLISH PROPER VEGETATION AND LIMIT SOIL EROSION. A MINIMUM THICKNESS OF 3" OF TOPSOIL MUST BE APPLIED TO THE LIMITS OF THE GRADING FOR THE BASIN AND THEN SEEDED AND MULCHED. THE MATERIAL UTILIZED IN RESTORATION OF THE BASIN SHALL ADHERE TO ODOT ITEMS 652, 653 AND 659.
