KIDS JABER, LLC LIONS PARK ALLOTMENT & CONDOMINIUMS MARION AVE, SPRINGFIELD TOWNSHIP, OHIO	DATE	11/19/04	REVISION	3 SUMMIT CNTY CHARTS
	DRAWN	CHECKED	DATE	04-24-15
PLAN & PROFILE EAST SAN. TRUNK	SCALE	HOR: 1" = 20'	VER: 1" = 5'	
	STORM & SANITARY AS-BUILT 3-08-2016			
SPAGNUOLO & ASSOCIATES, LLC 3057 WEST MARKET STREET, SUITE 201 • FAIRLAWN, OH 44133 PHONE: (330) 836-6661 EMAIL: dsloffer@spagnuoloassoc.com

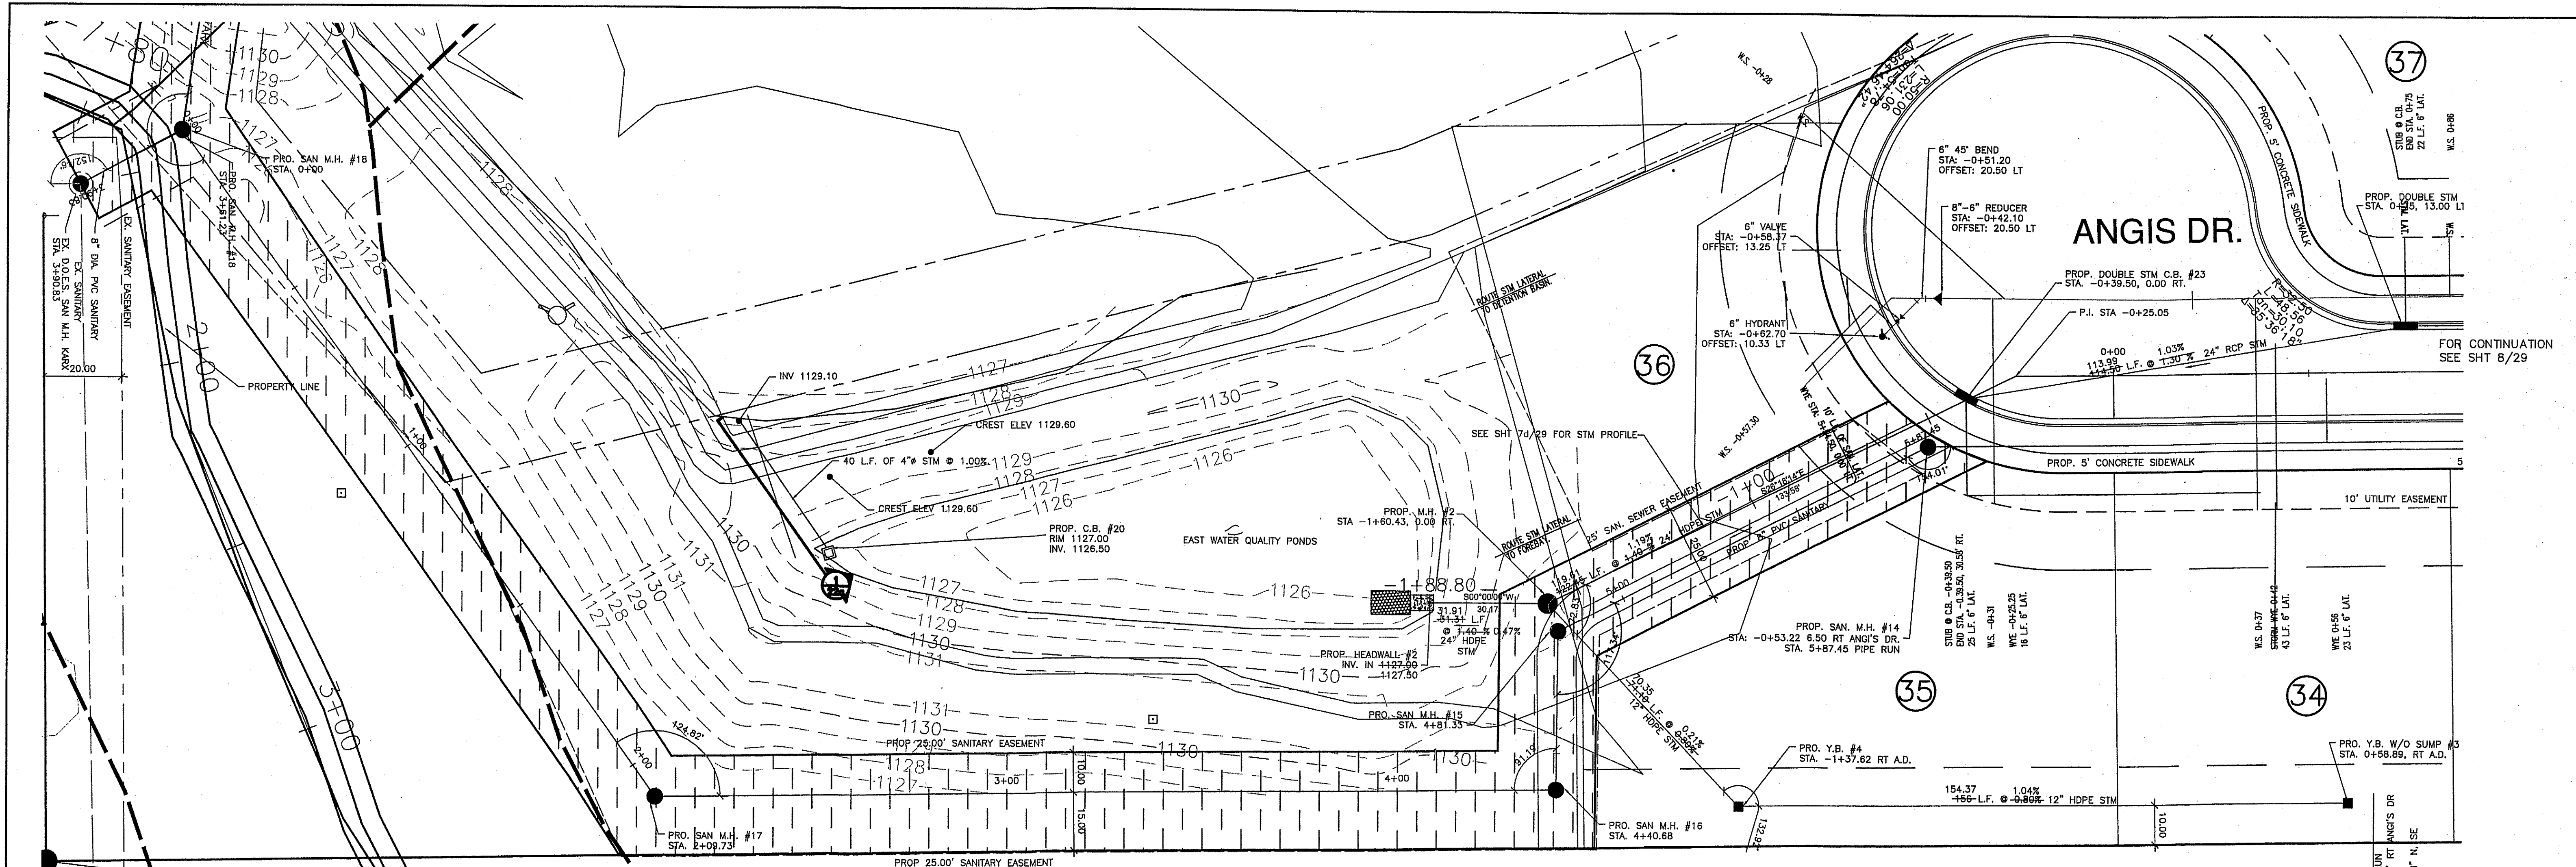
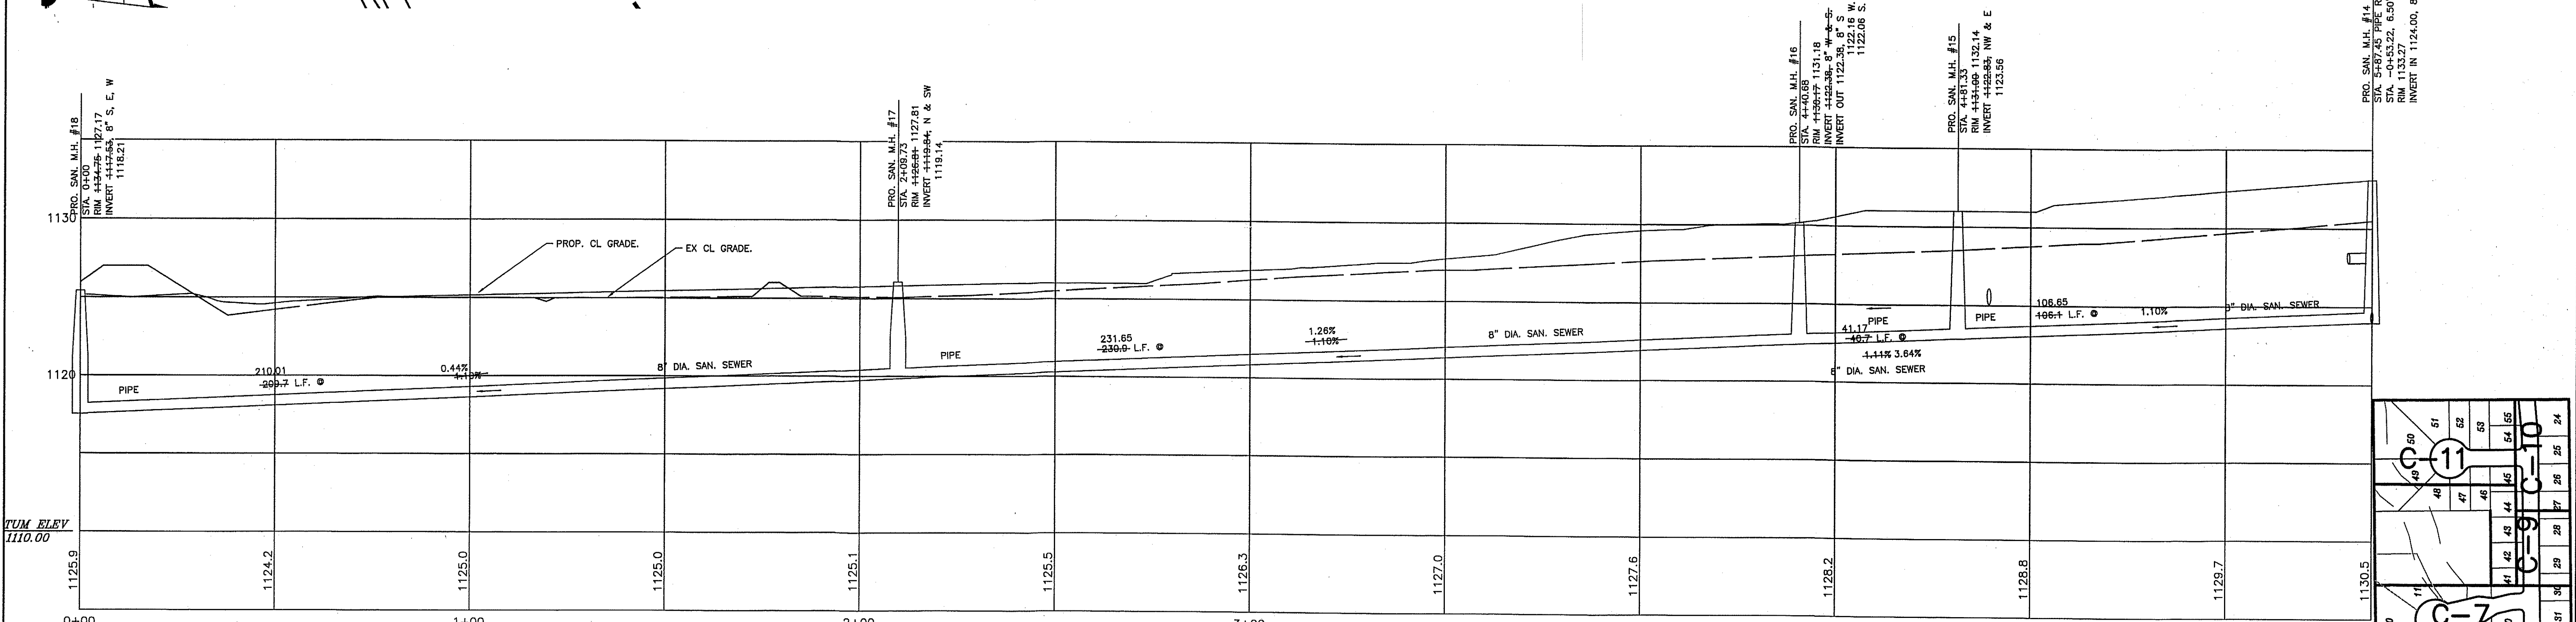
PROP. WATER SERVICE LOCATIONS

LOT	SIZE	LENGTH	LOCATION
46	1"	100.00 L.F.	4+64.00 35.00' LT.
47	1"	100.00 L.F.	5+30.00 35.00' LT.
48	1"	79.50 L.F.	5+60.00 35.00' LT.
49	1"	79.50 L.F.	6+40.00 35.00' LT.
50	1"	36.00 L.F.	7+64.00 35.00' RT.

LOCATION CALL OUTS FOR STM. AND WATER ARE TO THE END OF THE LATERAL
